INFO SHEET FOR WORKSHOPS & TECHNICIANS

What Is the Silica Bag Issue in VAG Cooling Systems?

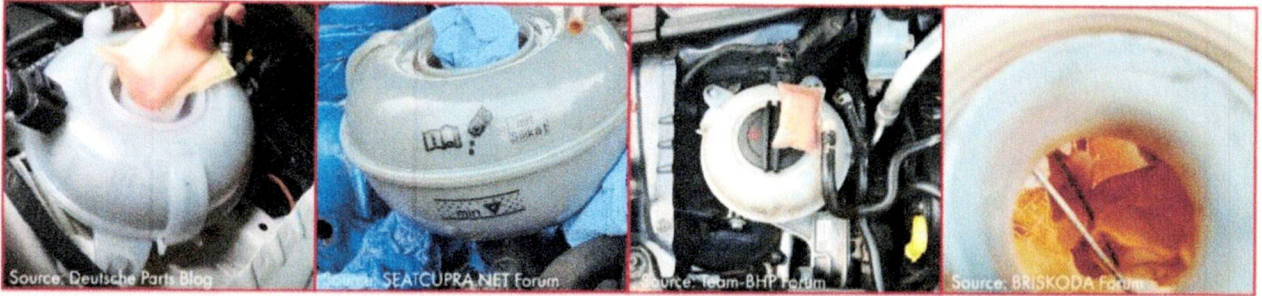
Between approximately 2013 and 2020, many Volkswagen Group (VAG) vehicles — including Volkswagen, Audi, Skoda, and SEAT models — were equipped with a coolant expansion tank that contains a silica (silicate) bag. This tank is often marked with the label “Mit Silikat”, meaning “with silicate.”

Label Check: Look for “Mit Silikat” printed on the expansion tank.

Visual Inspection: Shine a flashlight into the tank to spot the silica bag, often located on the side.

Part Numbers: Common part numbers for tanks with silica bags include 5Q0 121 407 and 7E0 121 407 B.

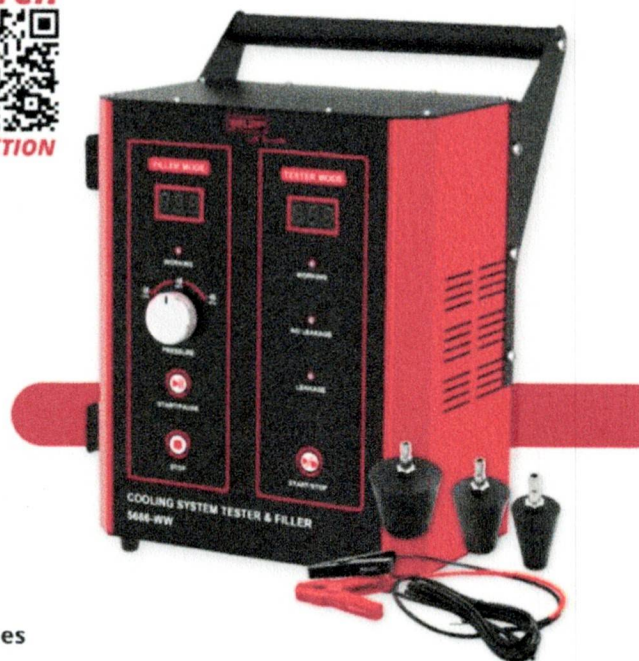
COOLANT-MATE™ 5686-WW

Automatic Cooling System Tester & Filler

The Coolant Mate™ is an advanced, fully automated tool designed for fast and efficient coolant system service. It combines vacuum-based leak testing with precision coolant filling, helping technicians detect system issues and refill coolant without introducing air pockets. Dual modes: Tester Mode and Filler Mode. Adjustable vacuum levels (-35, -40, -45 kPa) for compatibility with older and modern vehicles. Ideal for post-flush refilling and diagnosing flow restrictions caused by silica bag failures. Digital display with intuitive controls for easy, hands-free operation.

Silica bag failures can cause blockages, airlocks, and coolant contamination in many VAG vehicles. The Coolant Mate™ is engineered to not only handle these conditions — but to make diagnosing, flushing, and refilling faster, cleaner, and more effective.

Identify internal blockages caused by silica beads — even if there are no visible leaks. Quickly confirm whether the cooling system holds pressure and is flow-ready.

Use deep vacuum to draw coolant through even hard-to-reach areas. Prevents airlocks in heater cores that are common after flushing contaminated systems.

Select from -35 / -40 / -45 kPa depending on system age and sensitivity. Lower pressure settings are safer for older or partially blocked systems.

After flushing out silica or replacing the tank, Coolant Mate™ ensures fast, complete refills. Speeds up turnaround time while ensuring long-term cooling performance.
